Roof Edge Blow Offs

NRC Completed 2 Years of Wind Study to keep them on

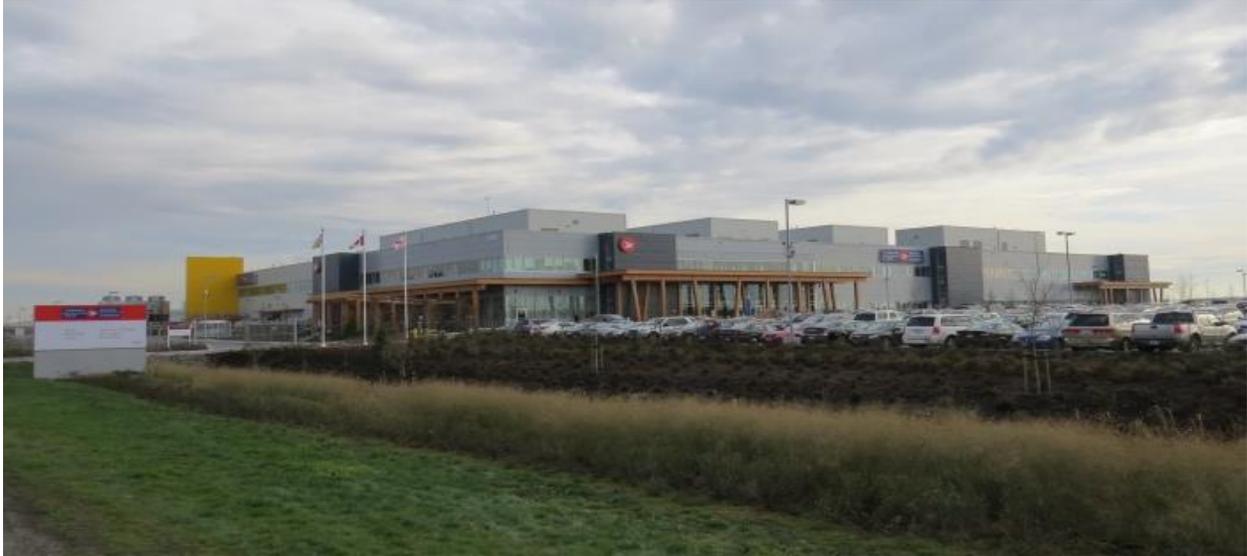
Figure 2: Sensor Installation Process: (a) Canada Post Pacific Processing Centre in Vancouver (b) Penthouse 6 of the Canada Post Building (c) Wind tower (d) Installation of sensors by Marine Roofing and NRC (e) Pressure sensors at roof edge

The Canada Post Pacific Processing Centre, located on the south side of the Vancouver International Airport, was identified as a suitable field monitoring site for this study. Positioned at an airport location, the building can be categorized as having an open terrain exposure with the predominant wind direction ranging from south-west to north-west. In order to be exposed to the critical wind direction range, instrumentation was placed on Penthouse 6, located on the west side of the building with a parapet facing the incoming west wind. Building owner, Michael Bryson, said ***“Canada Post has been involved with the NRC for the past 20 years, including participation in a major study to understand roof membrane properties in the late nineties. When the NRC was in search of a new building site, the Canada Post Pacific Processing Centre in Vancouver was an ideal choice for wind performance. For building owners like myself, this provides a comfort zone to know that the measured wind uplift forces are less than the designed values”.***

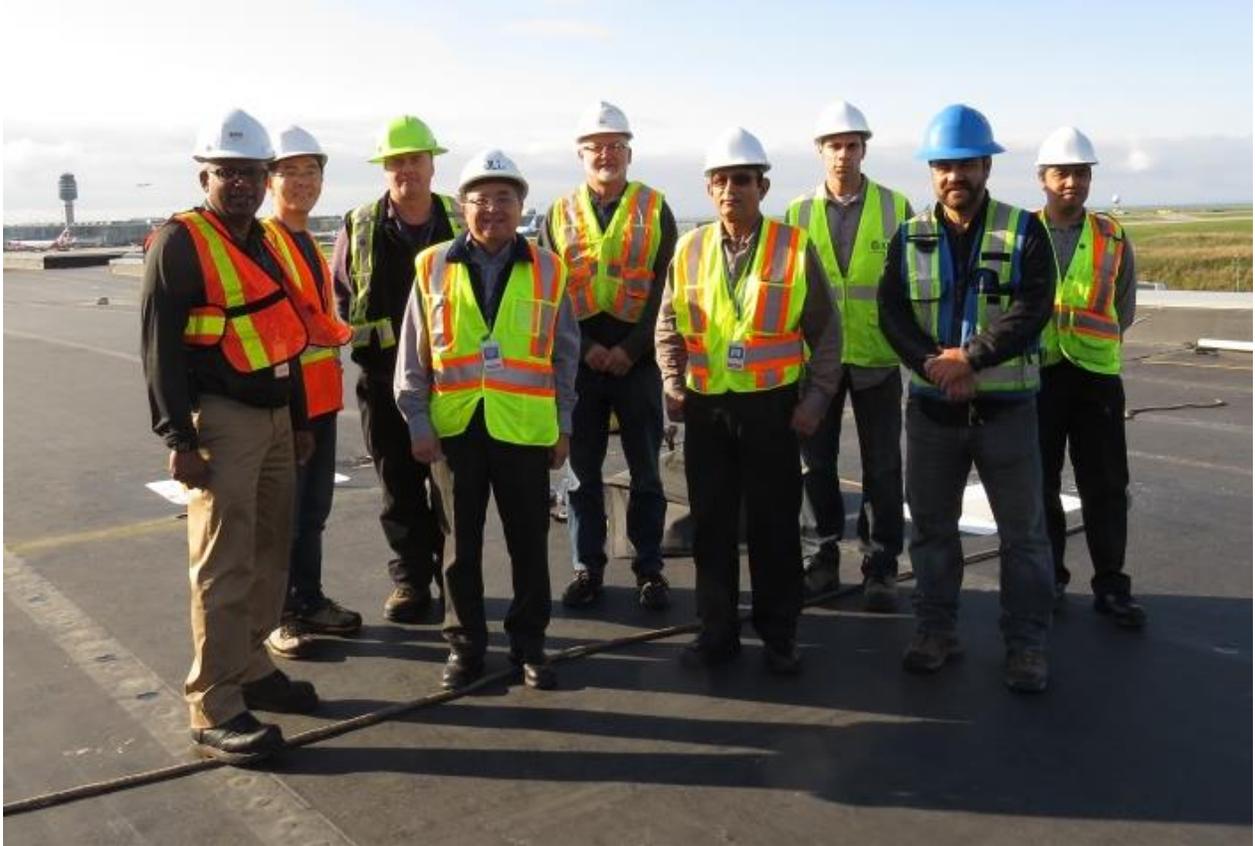
Figure 3: Sensor Removal Process: (a) Members involved with sensor removal (b) Extraction of pressure sensors (c) Repair and patching of insulation and membrane by Marine Roofing and Carlisle Syntec Inc
