## ADHESION OF TORCH-ON AND SELF-ADHESIVE ASPHALTIC MEMBRANES OVER GREEN CONCRETE

Laurence Matzek, RCABC, Leslie Peer, RJC Engineers, Jason Teetaert, SMT Research

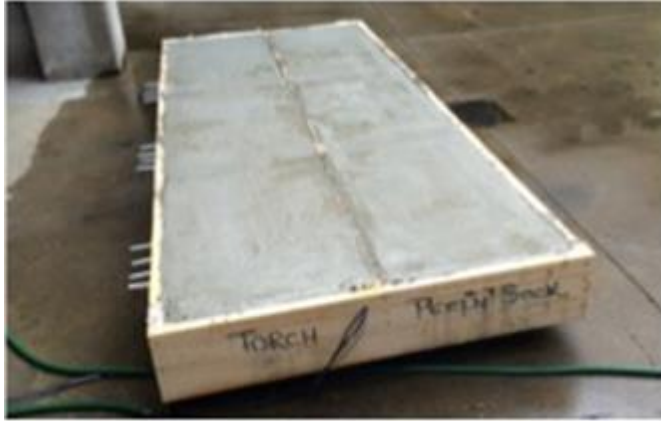
Figure 1: Concrete slab after casting

Two concrete slabs were built at RCABC's facility in Langley BC. The slabs were 1.2 m x 3m (4' x 10') in size and 0.15m (6") thick. They were cast against polyethylene vapour barrier on all 5 sides except the top surface which was left open to air after finishing. The concrete was a Class C4 25 MPa mix from a local ready mix supplier, with 14mm aggregate and 6% air entrainment, W/C ratio less than 0.55. Figures 1 and 2 show the slab configurations.

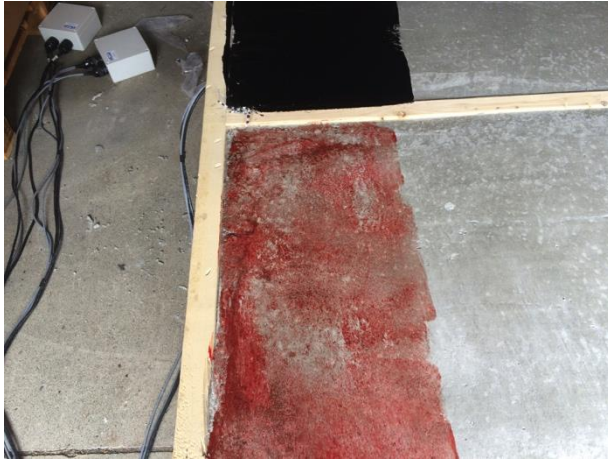
Figure 3 Application of Primer to Concrete Slabs on Day 1

On pre-determined dates, a 0.3m wide section of concrete was primed, and membrane was installed, Figure 3. The application methods were both torch applied membrane and self-adhesive membrane. The membrane was trowelled or rolled down, similar to membrane flashing applications.

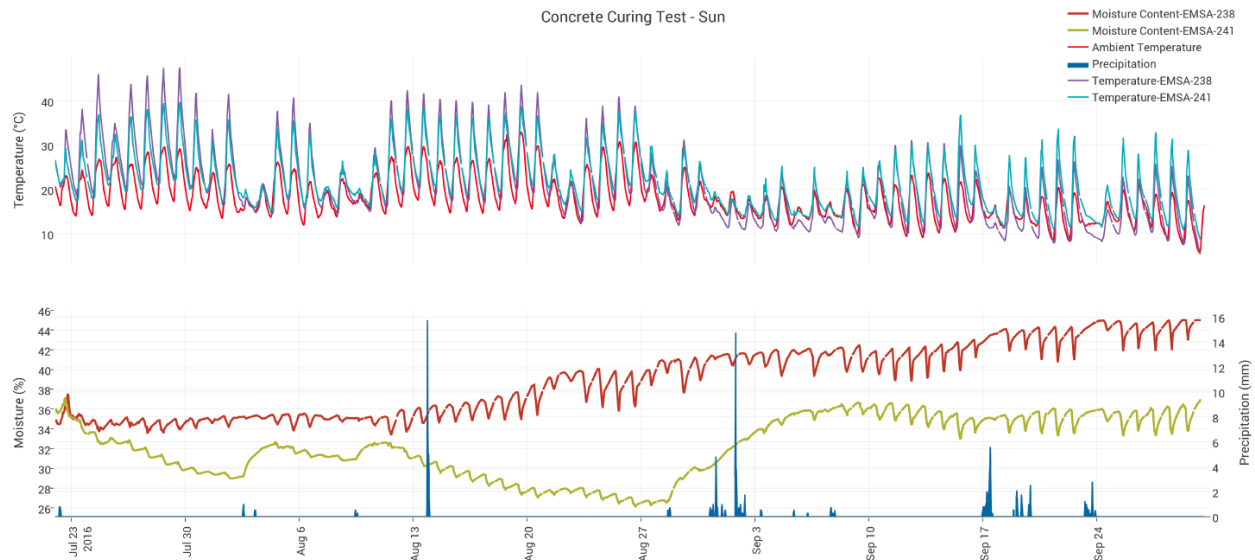
Figure 7: Temperature, Rain Events, and Concrete Moisture Content - Outdoor Slab

Moisture contents (MC) were measured with sensors cast into the concrete at opposite ends of the slabs, 40mm beneath the surface. In Figures 6 & 7 the red lines measure moisture content at the end of the slab which was covered on the first day after casting. The yellow lines are sensors at the other end of the slab, which were not covered until the 56<sup>th</sup> day (Sept 15). In Figure 6 for the sheltered and shaded slab, the covered sensor records nearly constant moisture content, which increases gradually as the slab ages. The other end of the slab dries steadily over the course of the dry summer months, as it is not exposed to rainfall, until it is covered with membrane on Sept 15, after which its MC also begins to trend gradually upward. The upward trend in moisture content measured by the sensors is likely due to gradually cooling weather, noted in the blue and grey temperature curves in the temperature data above, redistribution of moisture in the slabs, or to and may be affected by increasing maturity of the concrete.

In Figure 7 for the outdoor slab, the sensors record the effects of rain and exposure. The yellow line for the uncovered MC sensor responds with moisture content increases after each rainfall event, and then dries again, until it is covered on Sept 15<sup>th</sup>. The time delays for the wetting events are related to the time it takes to record moisture content changes 40mm beneath the concrete surface after rainfall at the surface. Moisture content of the concrete at depth for membrane applied at 14 and 21 days (on Aug 4 and 11) on the exposed slab were similar to the MC on Day 3, even though the surface was dry again. At Day 56, the moisture content was similar to Day 1 due to extended rainfall the previous week.

Concrete will absorb liquid water at a far higher rate than it releases vapour, and one small rain shower can undo days of drying (See Figure 7).

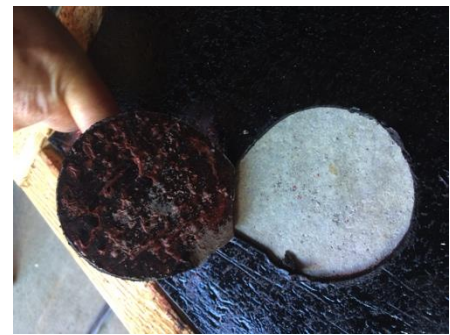
Figure 8: Sample 1 SAM test day 1 Shade

5. The pull test results were generally higher for the TFM versus the SAM particularly at early ages where little adhesion was achieved with the SAM for the first 7 days. The SAM primer seemed to be less interactive with the slab surface (very clean detachment from surface) Figure 8, and seemed to allow vapour diffusion from under the membrane (few blisters).

Photos of typical pull test pucks are shown in Figures 8-11. Samples from Day 1 show nearly complete delamination of the primer from the concrete in both TFM and SAM. Membrane applied after 28 days, and left in place for 28 days before testing had failure passing through the membrane to primer interface, or in the case of the TFM partly through the membrane (Fig 10 & 11). At 28 days, the character of the primer to concrete adhesion, and the membrane to primer adhesion behaved as it appears to be intended. However the bond deteriorated significantly for all Sun samples between 56 and 83 days when during demolition of the experiment the membrane was easily removed by hand, parting at the interface of the primer with

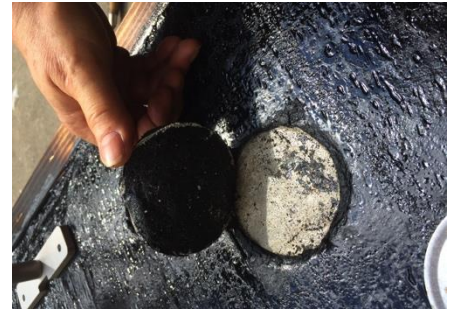
Figure 9: Sample 1 TFM test day 1 Sun

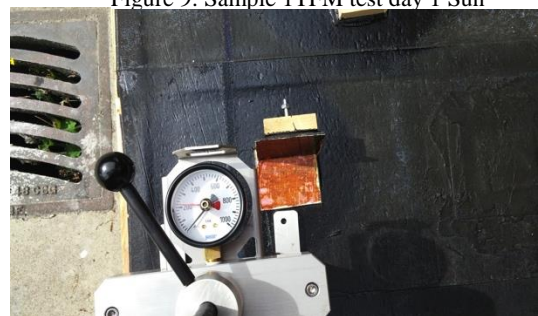
Figure 10: Sample 28 SAM Test day 28 Sun

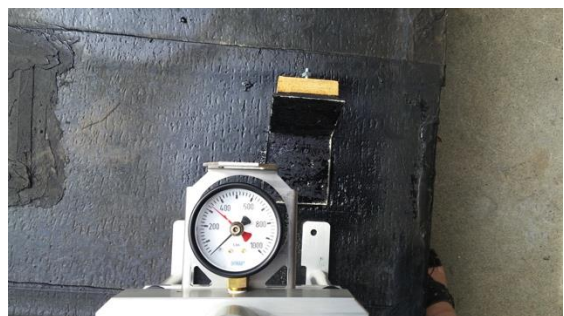
Figure 12: Sample 28 TFM test day 27

the concrete surface. Figure12

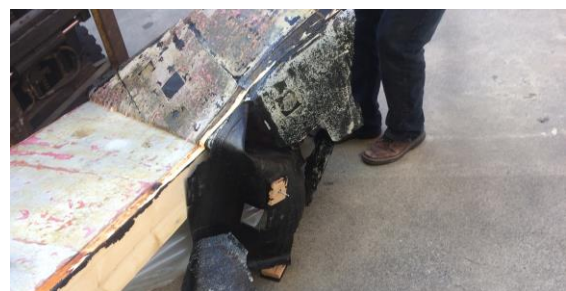
Figure 11: Removing membrane by hand from Sun slabs at 83 days

7. The concrete slabs were deconstructed on Oct 12, 2016, 83 days after the pour date. The membrane was easily pulled from the concrete slab. The top of the slab was moist to the touch, and the primer had been pulled up with the membrane.

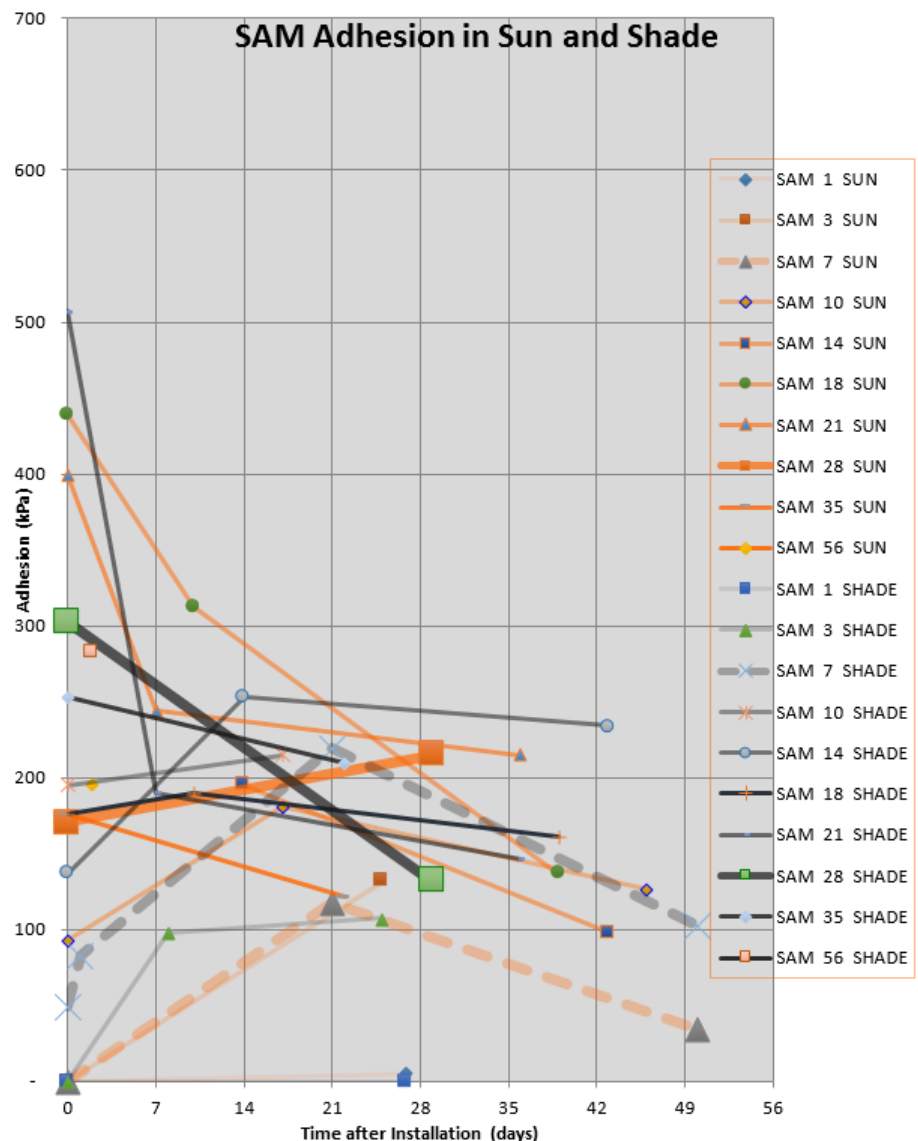
Figure 13: SAM Adhesion in Sun and Shade

Figures 13 and 14 are graphs of the test data presented in Table 1. Figure 13 plots the data for SAM exposed in the sun and shade, and Figure 14 the data for TFM also in the sun and shade.

General trends in the SAM data show first day adhesion increasing after about a week after casting of the slab. Samples in the sun did not begin adhering to the slab until after 14 days, while in the shade the installation after 7 days had some bond.

Sun and Shade exposed SAM appear to have similar late age bond strengths, with shade values slightly higher.

At 7 to 14 days after installation the SAM has generally moderate strength, with the high initial strength samples decreasing, and the low initial strength samples increasing in bond strength to lie in the range between 100 to 250 kPa.

14 to 21 days after installation all the SAM samples show decreasing bond strength, a trend which continues for the samples out to 50 days.

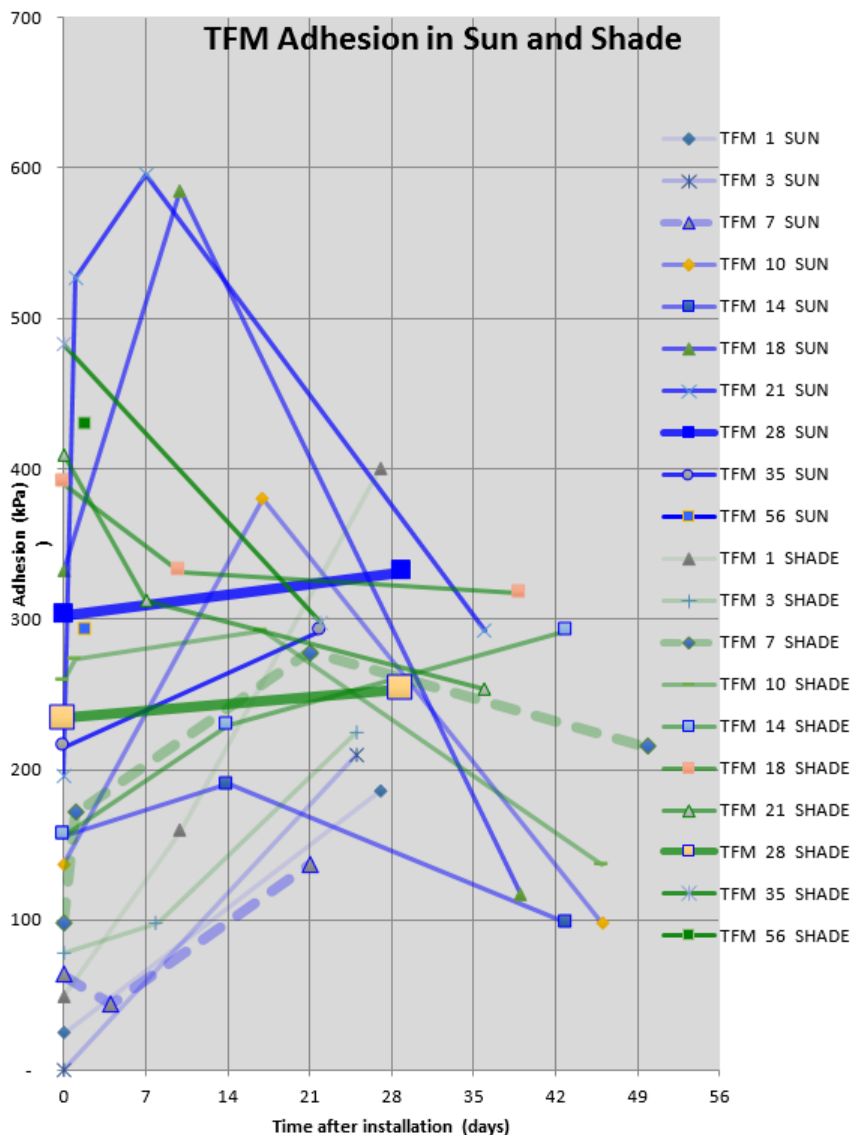
Figure 14: TFM Adhesion in Sun and Shade

Thermofusible membrane showed generally higher bond strengths, but otherwise many of the same trends as the SAM bonding. Only the Day 3 TFM installation had 0 bond strength on the first day. Early age installations generally gained strength for the first two weeks,

3 weeks after installation, most installed TFM were in the range of 150 to 400 kPa. After 18 to 21 days many early installed Sun strength curves were decreasing, a trend that continued out to 50 days. The membranes installed after 28 days had stable bond strengths but this trend was not verified past 28 days since most testing for these samples ended at 28 days.

Late age bond strength of the Shade samples appear to be consistently higher than Sun exposed samples.
