ROOFING CONTRACTORS
ASSOCIATION OF
BRITISH COLUMBIA

TECHNICAL BULLETIN

Failing Flashings

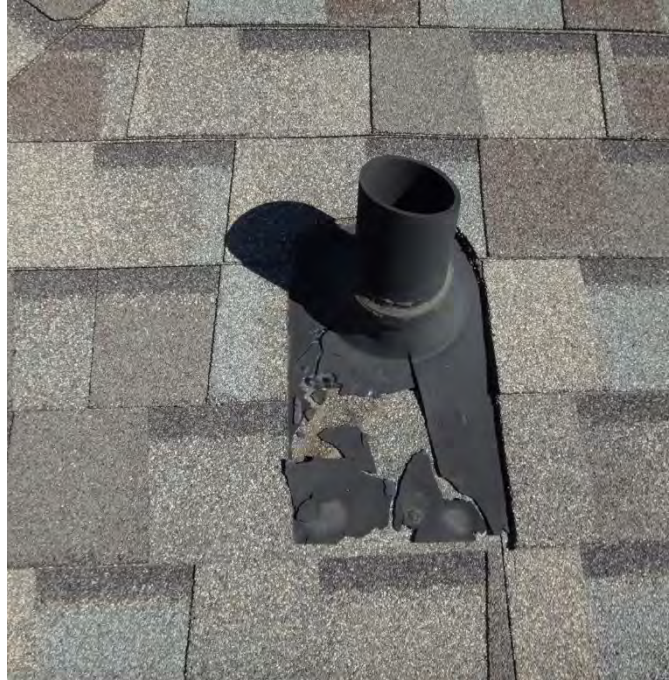
In the past several weeks, two more multi-residential projects in British Columbia have seen similar failures. The issue is widespread, affecting every pipe penetration across each complex. In every case, failure occurred 4 to 8 years after installation and impacts the exposed part of the flashing. At least 3 different manufacturers' products are involved.

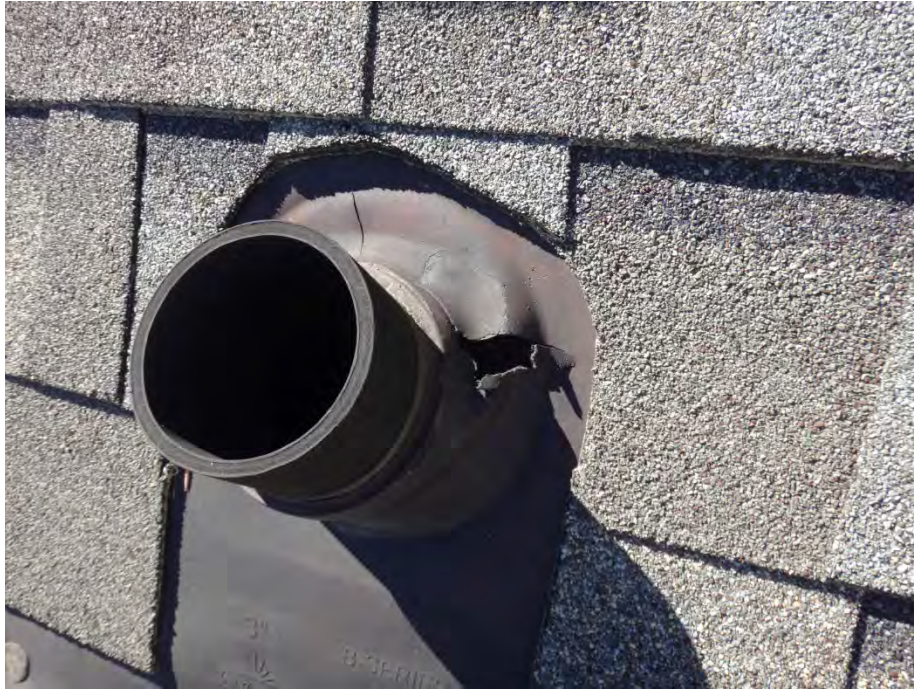
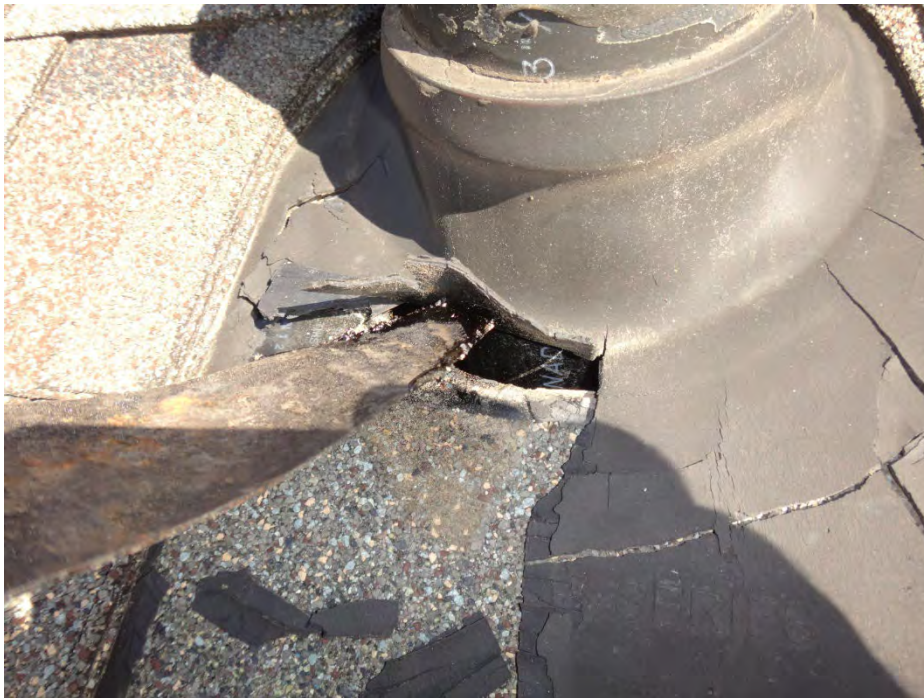
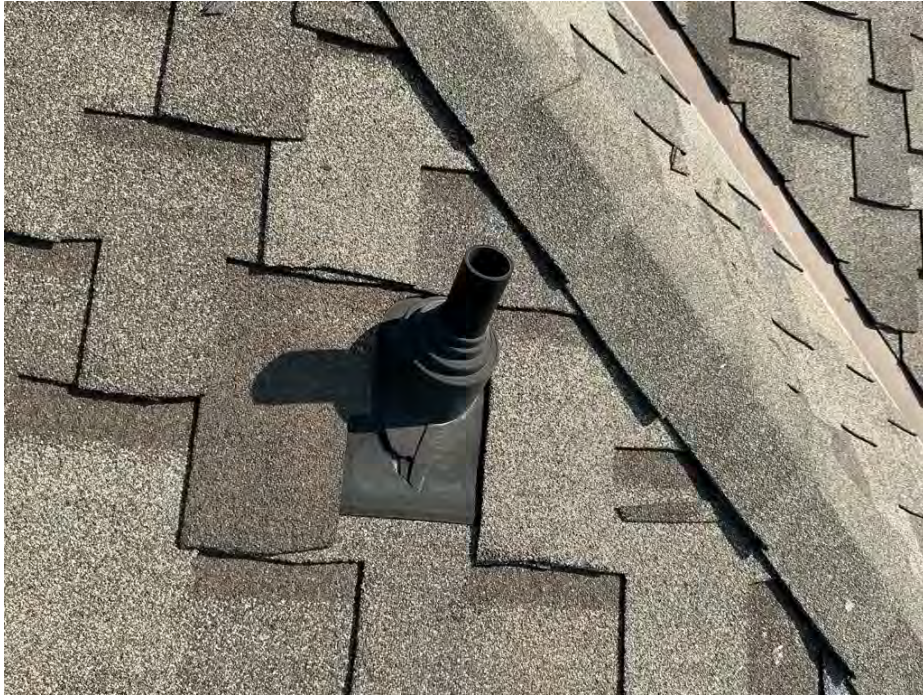
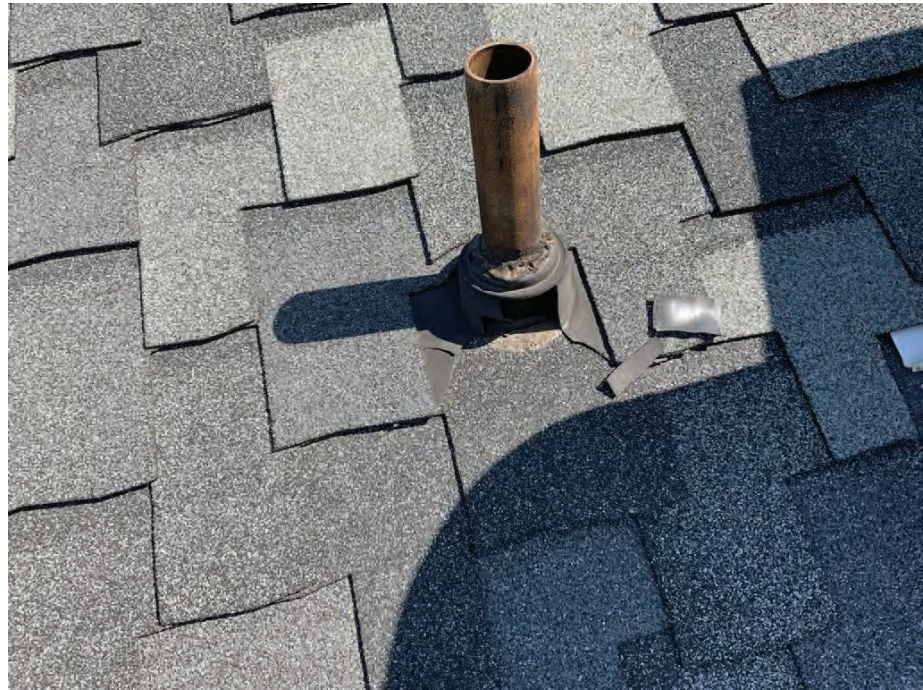
Below are photographs depicting the nature and severity of these failures.

Because the issue of disintegration appears to be endemic to this type of flashing, the RGC is placing a temporary ban on the use of these flashings, effective immediately for projects bid on or after October 29, 2024. The issue may lie with UV inhibitors or other modifiers in the compounds used to make these flashings, or it may be environmental, but until we understand the nature of the problem and have identified a way to correct it, the RGC will exclude any of these flashings from coverage under a RoofStar Guarantee.

There are other options available to our Member Contractors. Spun aluminum flashings purpose-made for pipe penetrations are a suitable option, provided they are manufactured with a squared base so that they can be flashed into the asphalt shingle system with a horseshoe-type membrane flashing (Article 12.3.2.1., "RGC Standard for Asphalt Shingle Roof Systems"). Where possible, settlement caps should be used to enclose the pipe penetration and prevent leaking between the penetration and its flashing. When use of a settlement cap is not possible (because of the length of the penetration), the RCABC Member Contractor must use an alternative method such as an EDPM wrap, described in the Waterproofing Roof Standards, Article 12.3.2.1.

Lead flashings may also be used but must be handled with appropriate PPE.
